# SMT Troubleshooting

## Typical SMT Problems

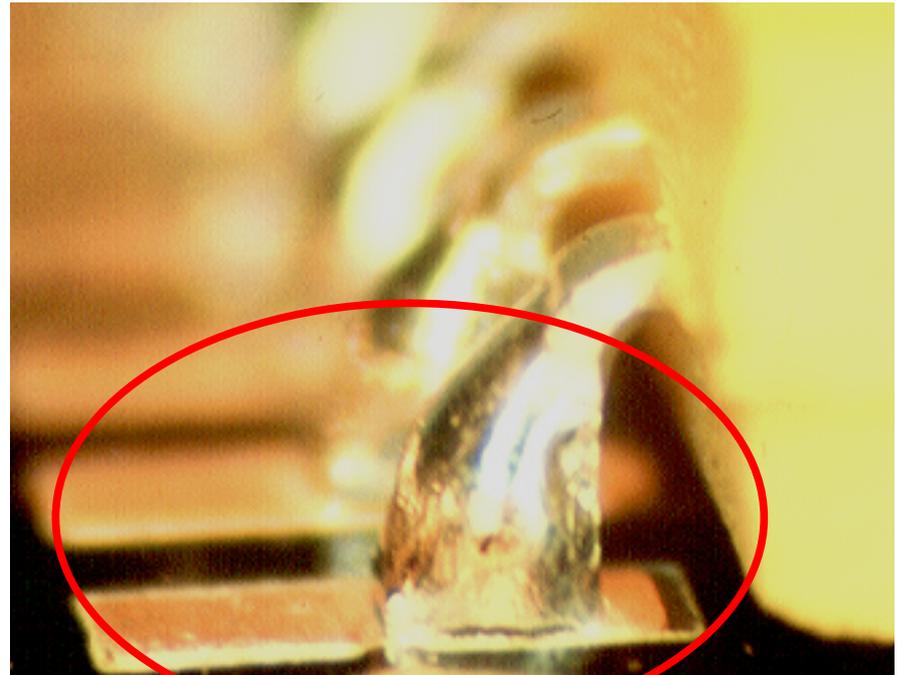
- Possible Cause:
  - Solder paste wicking up leads as a result of uneven or excess heating.
- Remedy:
  - Reduce the reflow peak temperature.
  - Increase bottom-side heat.

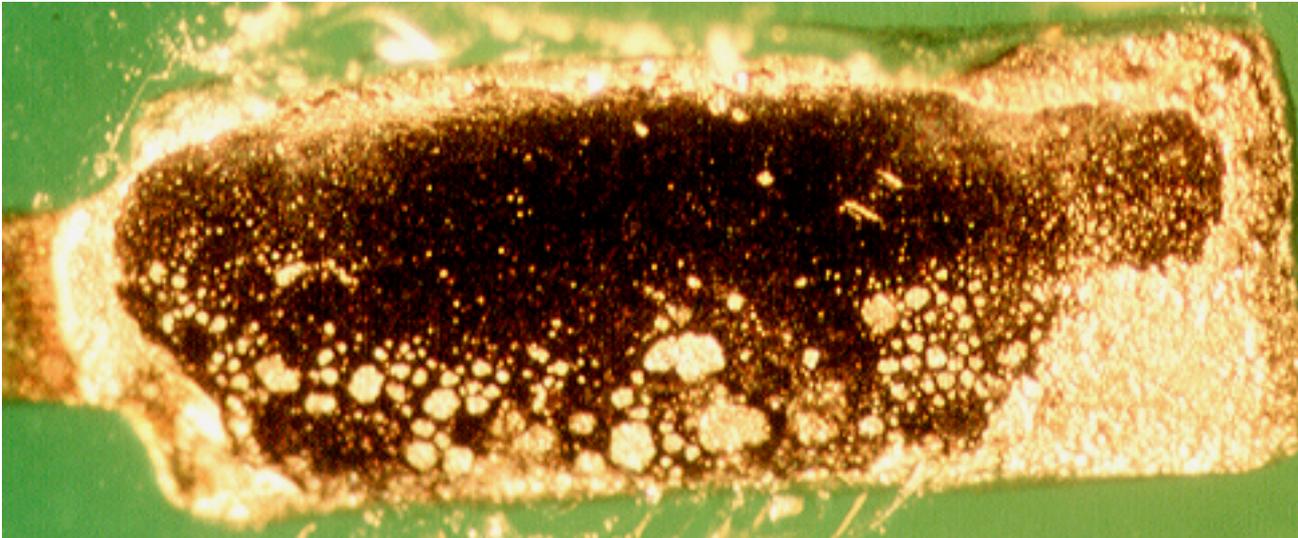
- Possible Causes:
  - Contamination of surface by abrasives
  - Poor plating
  - Poor hot air solder leveling during PCB manufacture
